Manhole Inspection Summary

Manhole # S04GG2001MH

Insp Date: **8/14/06 12:00 AM**

Location Address: **3312 FALLSTAFF RD**

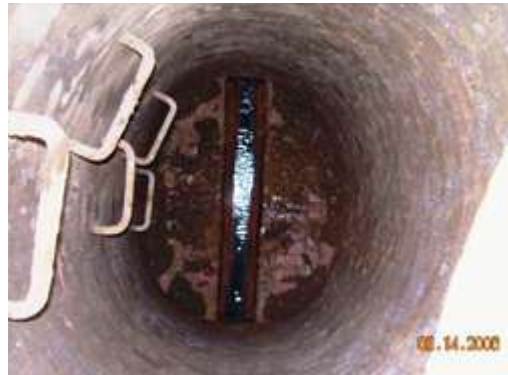
Top View

Infiltration: ☐ None ☐ Joint ☐ Cracks ☐ Mortar ☐ Roots ☒ **Wall**

Bench ☒ Exists Material: **Brick** ☐ Parged ☒ **Debris** (not Condition related)

Steps Count: **5** Missing: **0** ☒ **Corroded**

Surcharge ☒ **Evidence Of Surcharge** Depth: **1** (ft.) ☐ Active Surcharge Present

Corroded steps. Evidence of surcharge - Bench debris. Adjustment, Corbel, and Barrel infiltration.

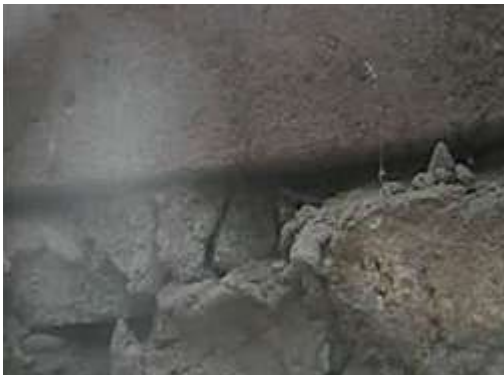
Defect

Condition: ☐ Sound ☐ Cracked ☐ Root Intrusion ☒ **Loose Brick** ☒ **Deteriorated**

Infiltration: ☐ None ☒ **Joint** ☐ Cracks ☒ **Mortar** ☐ Roots ☒ **Wall**

Frame leaks. Adjustment deterioration and loose brick. Adjustment infiltration.

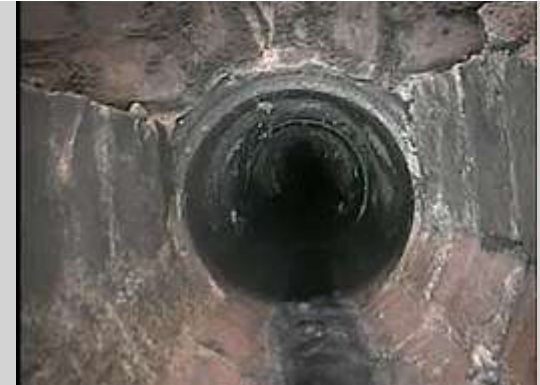
8 in. Circular Gravity Sewer Pipe Out @ 12 O'Clock

Infiltration: **Evidence** Pipe Seal Cond: **Unknown**
